The Swivel Repair Kit PMA036903 is for seal replacement on leaking swivels only. No other repair parts are available. The open bearing on the swivel can be cleaned & re-greased if needed, but if the swivel bearings are bad, the swivel must be replaced with a new swivel.

Complete Swivel – NX100 shown. Repair procedures are the same for the NX101 swivel. Swivels NX105 & NX108 do not use jam nuts, but internal parts are the same.

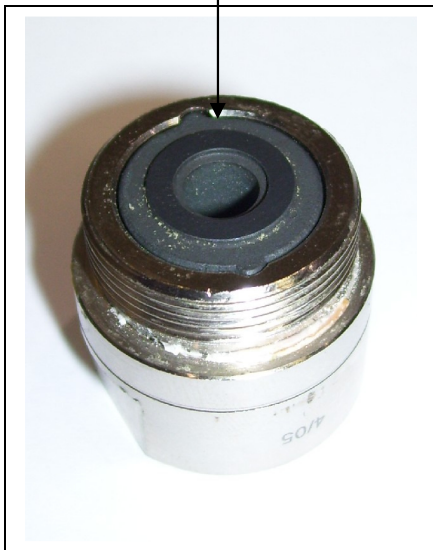
CERAMIC SEAT ⑨ (shown in Swivel Top ⑫)

SMALL O-RING ⑪ (shown in Swivel Top groove)

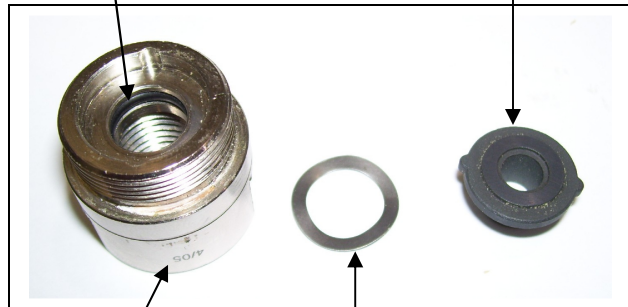
CERAMIC SEAT ⑨

Swivel Top ⑫

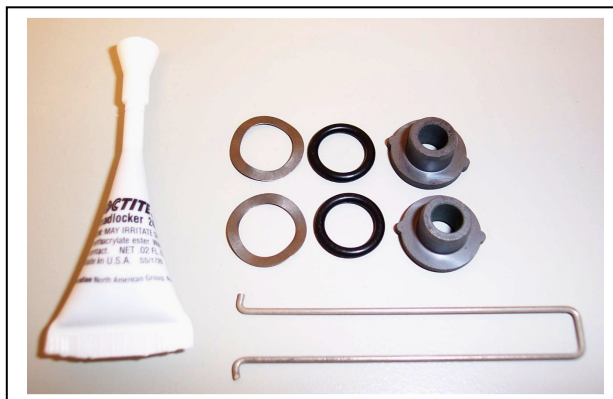
SWIVEL REPAIR KIT

CUPPED WASHER ⑩

PMA036903

Kit Includes:

2 – Ceramic Seats

2 – Cupped Washers

2 – O-Rings

1 – Seat Puller Tool

1 – Tube Loctite 242 - Blue
